Design & Construction of a High Geogrid Reinforced Wall

Ir. Lee Eng Choy
Senior General Manager (Technical), Emas Kiara Marketing Sdn Bhd

A housing project on a hill site requires the construction of a 17m high reinforced soil wall supporting a 20m high reinforced soil slope. At the top of the slope were sited double storey terrace houses founded on raft foundations. Beneath the foundation of the wall, a disused sewage treatment pond was reclaimed, with soft slime excavated and replaced with compacted rockfill to form the foundation of the wall. Woven high strength geotextile was used as the base reinforcement immediately above the rock foundation. A 17m high reinforced soil wall of gradient 4v:1h was constructed with geogrids. Immediately above this steep wall was a reinforced soil slope of gradient 1v:1.7h, reinforced with woven high strength geotextile. The structure was designed to limiting differential displacements at the top where the buildings were sited. Hence, extensive monitoring of the displacements was carried out. This paper describes the design concept, construction methodology adopted and the monitoring results recorded.

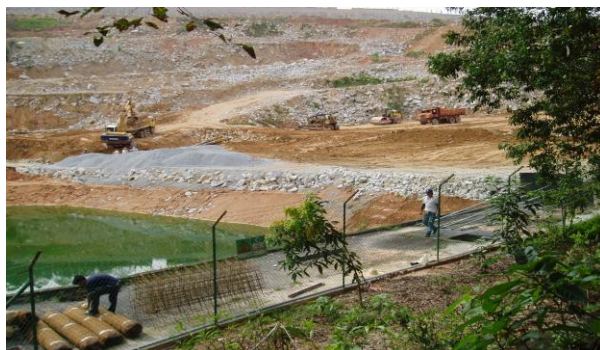
Figure 3: Rock-fill Base of Structure

As mentioned in the introduction, the retaining structure was sited on a disused sewage treatment pond. The base of the pond was filled with soft slime up to a depth of about 3m. This soft material was excavated and replaced with compacted rockfill to form the base of the structure. The excavation is terminated when the Mackintosh Probe tests reached a resistance of 75 blows per 300mm penetration. Figures 3 and 4 below show the completed rock-fill base of the structure.

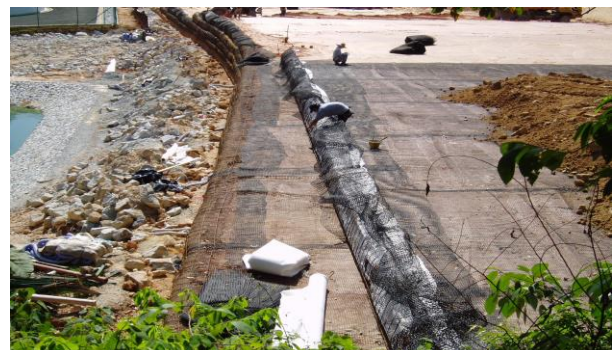
Figure 4: Base of Structure

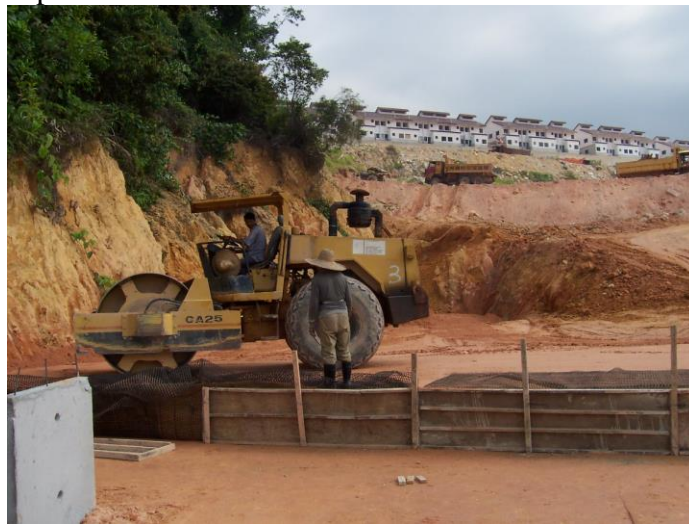
Figure 7: Compaction of backfill material in progress

During the installation process a 150mm thick cover of backfill material was maintained between the tracks of machinery and the geogrid in order to avoid damage to the geotextile material. All rocks and boulders greater than 100mm were also removed from the backfilled materials. Compaction of fill material within 1m of the front face were carried out using light hand-held compactor, including the plate vibrating compactor, while other part of the reinforced block were compacted with vibrating compactor roller.

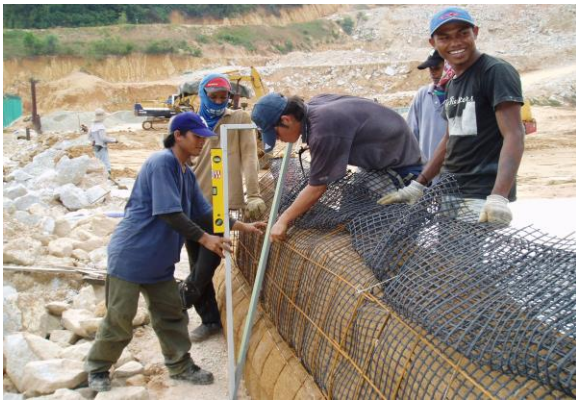
Figure 8: Installation of the wrap-around facing of the geogrid

Suitable backfill material was then placed on the Geogrids and compacted to at least 90% of its maximum dry density as determined using 4.5kg rammer method as specified in BS1377:1990. A wrap-a-round facing was used to contain the reinforced structure. This was carried out by wrapping the final portion of the grids towards the inner slope and slightly stretch and taut it. This was then anchored to the soil by partly burying the geogrids into the backfill material.

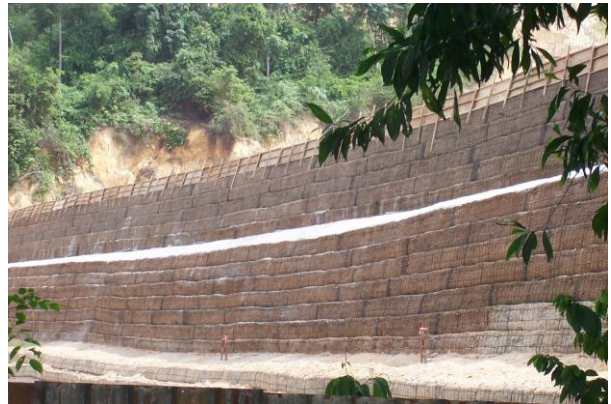
Figure 9: A completed section of the geogrid wall

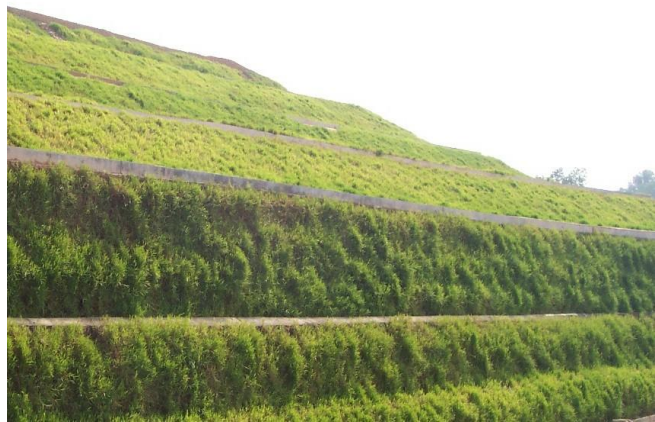
Figure 11: A view of fully vegetated facing

KiaraGrid, KG 150/25, KG 100/25 and KG 75/25 were cut to the required length inclusive that of the wrap-around length. A layer of Eco-Biomat geotextile was placed on the inner side of the geogrid. The function of the Eco-Biomat was to facilitate the germination of vegetation on the facing of the reinforced soil structure.

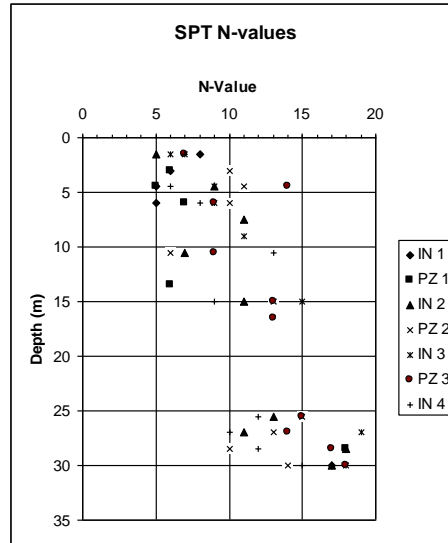
Figure 13: SPT N-values within compacted fill material

A series of monitoring systems comprising of inclinometers, settlement markers and piezometers were installed to monitor the performance of the reinforced soil wall. Whilst installing the inclinometers and piezometers, soil tests including the SPT were carried out in the boreholes. Figure 13 below shows records of the SPT N-values measured within the compacted fill. The N-values generally ranged from 5 to about 15 in the fill material. The low values and the scatter is consistent with the compaction densities and moisture contents observed, These results suggests low compaction densities at the locations tested.

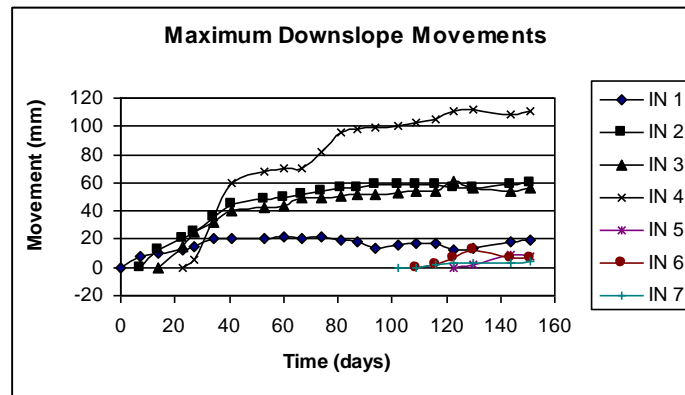
Figure 14: Maximum downslope movements of inclinometers

The inclinometer readings show that the structure moved a significant movement in the initial stages but stabilised towards the end of the monitoring period. The large movements recorded in the early stages of the construction were thought to be due to the straightening and tensioning of the geogrid.

Inclinometers and piezometers were installed from the fourth, fifth and sixth berms of the structure. The maximum downslope movements of the inclinometer readings are shown in Figure 14 below:

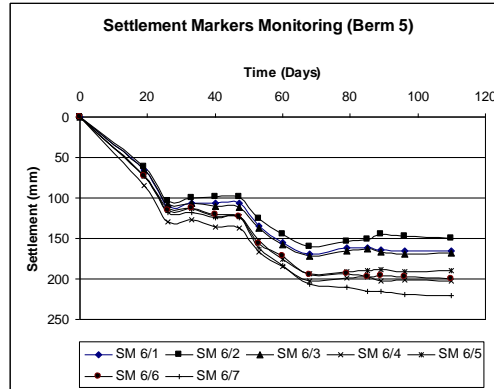
Figure 15: Records from the Settlement Markers

The records from the settlement markers are shown in Figure 15 below. The results show that the structure has reached stability with respect to the vertical movements.
