Application of Geotextile Tubes as Submerged Dykes for Long Term Shoreline Management in Malaysia

ABSTRACT: The shoreline in Malaysia has experienced severe erosion due to the impact of high energy waves, both on the predominantly mud coasts and the predominantly sandy coasts. This perennial process has resulted in the deterioration of the quality of the beach on the sandy coasts and loss of valuable land. Several measures had, in the past, been implemented to mitigate these adverse effects but these had predominantly been hard solutions. The application of geosynthetic tubes for shoreline management was introduced in the State of Terengganu on the east coast of Peninsular Malaysia which experiences severe erosion during the North-East Monsoon period. A pilot project by the Public Works Department, utilizing geotextile tubes installed as submerged dykes, was undertaken in 2006 to address the erosion problems and arrest the further erosion of the shoreline at Teluk Kalong, Kemaman, Terengganu. The geotextile tubes comprise of high strength woven geotextile infilled with sand slurry. Subsequently in 2008, the department implemented a similar shoreline protection project at Pantai Ba

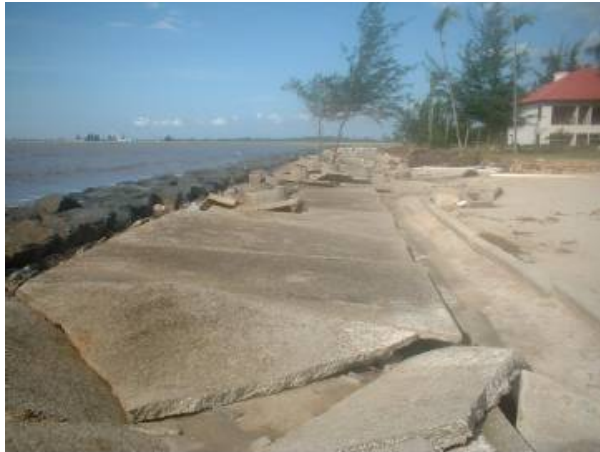
Figure 2: Concrete units used for erosion protection

harden and armour selected areas against wave attack as well as the use of groynes to trap sediments and alter long-shore transport. These include rock revetments, concrete-faced bunds and dykes, and rock-filled or concrete groyne structures. Examples of these are indicated in Figures 2 to 4.

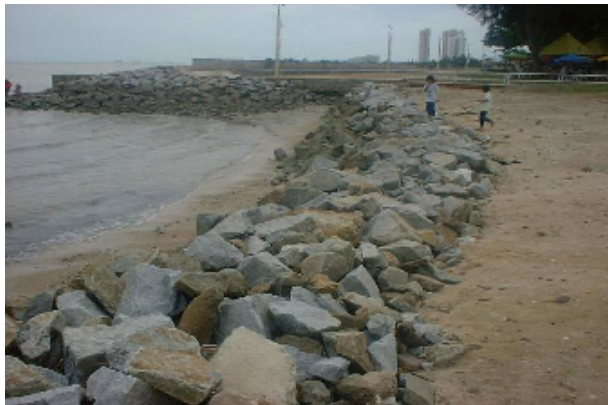
Figure 3: Rock revetment used for erosion

The function of the revetment structure is to prevent the loss of shore sediment and to limit wave run-up from overtopping the structure. Wave run-up is reduced by the roughness of the revetment surface and the size of the rocks is determined by wave height. Soil

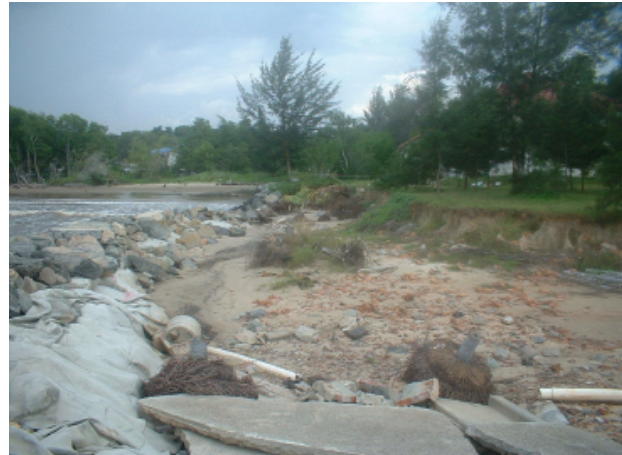
Figure 5: Failure of protection measure protection

Common causes of failure to these hard structural measures are undermining of toe, excessive settlement, failure due to lateral movement, overtopping and flanking. Failure of filter system will also result in excessive loss of materials behind the structure (Figure 5) and may result in excessive settlement.

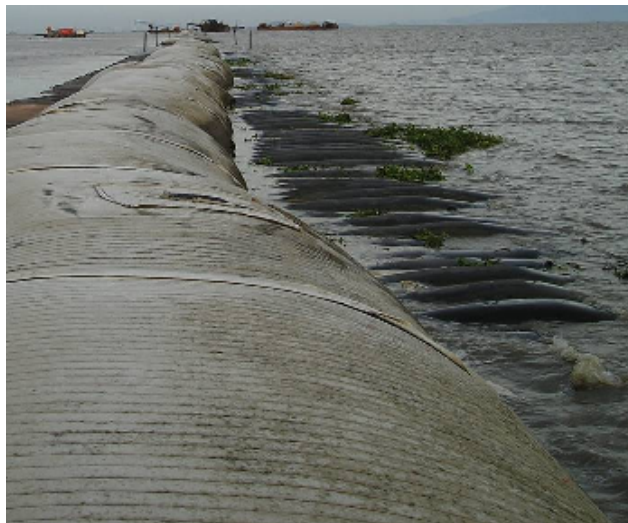
Figure 6: Geotextile tube used for coastal protection works

An example of the application of the geotextile tube in coastal protection works is shown in Figure 6.

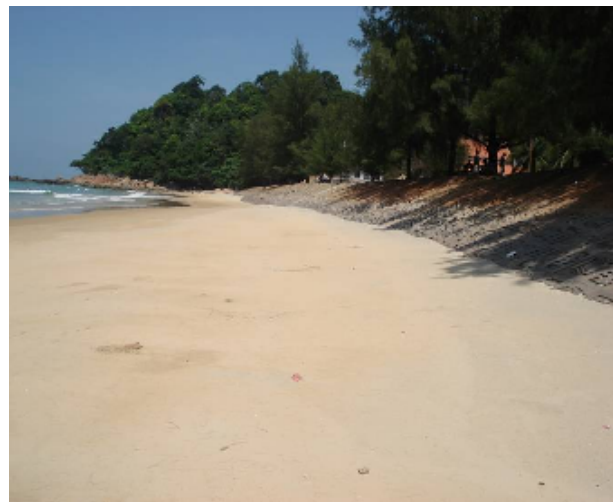
Figure 11: Condition of shoreline and beach in December 2009 after completion of submerged geodykes installation

The installation works were completed before the onset of the monsoon season in December 2006. Following two monsoon seasons in 2007 and 2008, a visual inspection of the project site was carried out. Figure 11 shows the improved condition of the beach profile with accumulation of sediments on the foreshore following completion of the submerged geodykes.

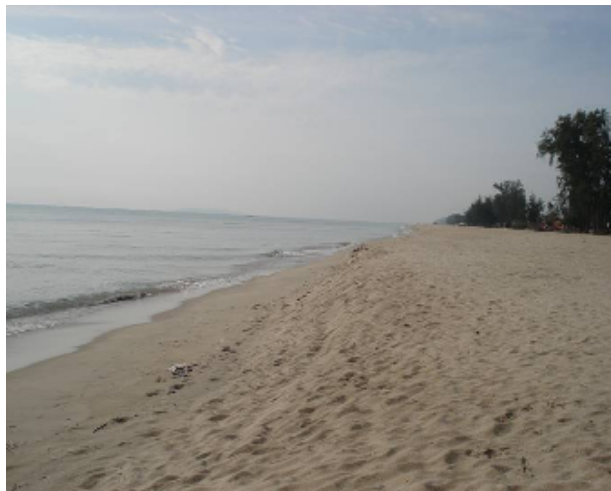
Figure 15: View of Beach at Pantai Batu Buruk (June 2008)

Figures 15 and 16 illustrate the condition of the beach in 2008, prior to the commencement of the project.

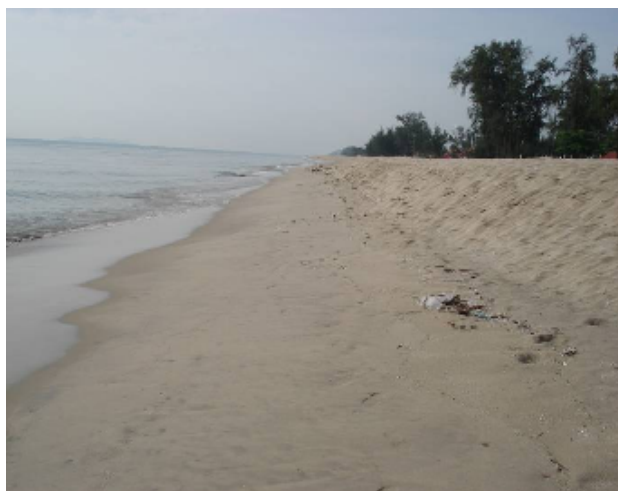
Figure 16: View of Beach at Pantai Batu Buruk (June 2008)

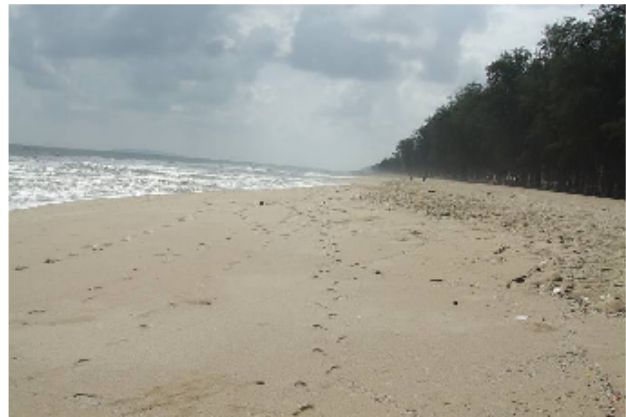
Figure 17: View of beach after the monsoon storm (March 2009)

The results of the post-monsoon hydrographic and topographic survey indicated that at the sections where geotextile tubes have been installed, the beach has not suffered further erosion. In contrast, sand deposits were clearly noted where previously there were steep scarps. The gradient of the foreshore area had also become gentler (PWD, 2009). These changes are illustrated by the following photographs taken after monsoon storms.

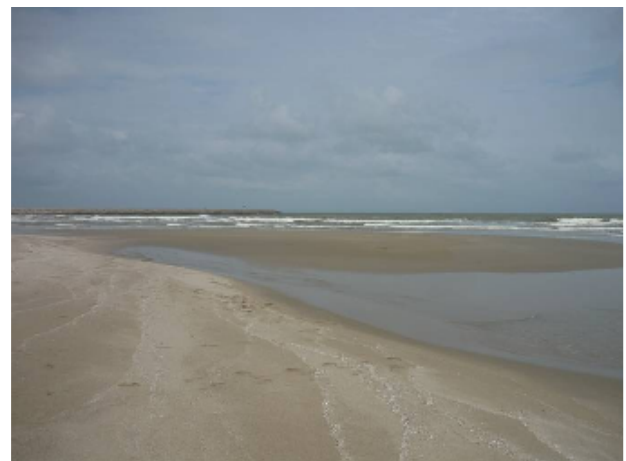
Figure 18: Sand deposited on foreshore area (March 2009)
